# **Engineering Geophysical Investigation of Road Failure in a Basement Complex Terrain, Southwestern Nigeria**

Geoelectrical and geotechnical investigations were conducted to determine factors responsible for pavement failure in some segments of Adebayo Alao-Akala road in Ibadan, southwestern Nigeria. The geoelectrical investigation employed Schlumberger vertical electrical sounding conducted at fifteen stations occupied along two failed segments and one stable segment of the road, using station spacing of 25 m and maximum electrode spread of 100 m. 2D electrical resistivity survey was also conducted using the dipole-dipole electrode array with electrode spacing,  $a$ , of 1 m and expansion factor,  $n$  varied from 1 to 5 m. The VES data were interpreted quantitatively by partial curve matching and computer iteration technique and geoelectric sections were generated while 2D resistivity structures of the subsurface were produced from the inverted 2D resistivity data. The geotechnical investigation involved Grain size distribution, Atterberg limits, Compaction and California Bearing Ratio tests conducted on subsoils collected beneath the segment. The failed segments are underlain

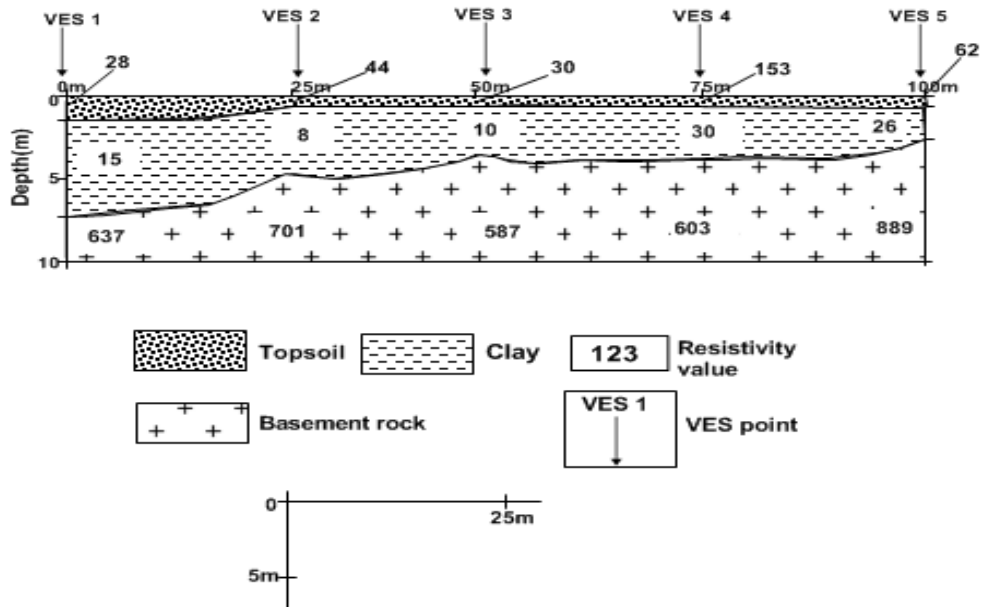
Fig. 4. Goelectric section beneath Failed segment A

The vertical electrical sounding data are presented as geoelectric sections while the 2-D dipole-dipole resistivity data are presented as inverted 2-D sections. Failed segment A is underlain by three geoelectric layers defined as topsoil, clay and bedrock (Fig. 4). The resistivity and thickness of the topsoil is 28-153 ohm-m and 0.9-1.6 m respectively. The clay layer has resistivity ranging from 8  $\Omega\text{m}$  to 30  $\Omega\text{m}$  and is 2.9 m to 4.9 m thick. Resistivity of the bedrock ranges from 587  $\Omega\text{m}$  to 889  $\Omega\text{m}$  while depth to bedrock is 3.9-5.7 m.

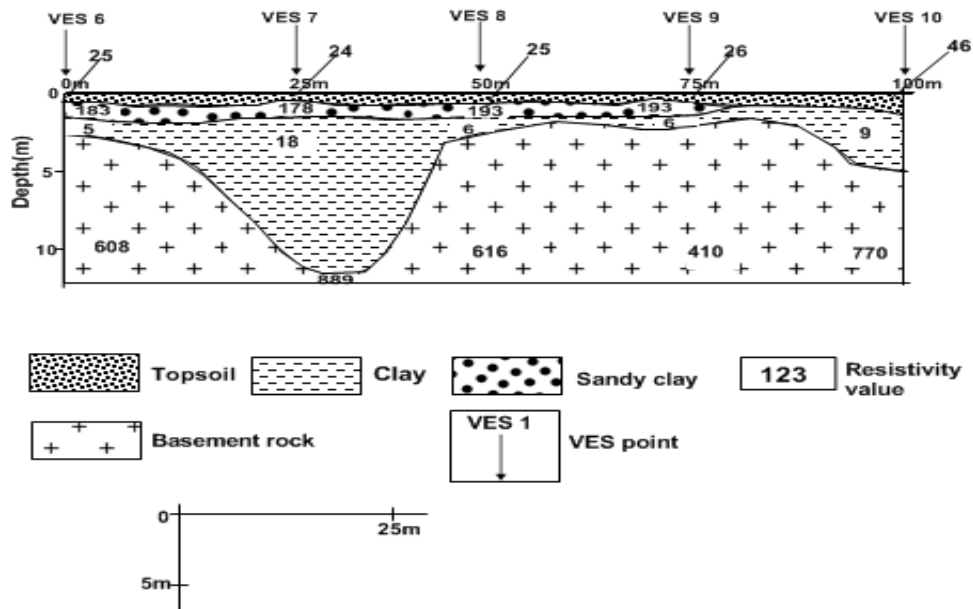
Fig. 5. Goelectric section beneath Failed segment B

The geoelectric section beneath Failed segment B (Fig. 5) shows four geoelectric layers defined as topsoil, sandy clay, clay and bedrock. The topsoil has resistivity values ranging from 24  $\Omega\text{m}$  to 46  $\Omega\text{m}$  and thickness from 0.5 m to 1.1 m. The resistivity of the sandy clay layer is 178-193  $\Omega\text{m}$  and is 0.8-1.0 m thick. The resistivity and thickness of the clay layer are 5-18  $\Omega\text{m}$  and 1.9-10.8 m respectively. The bedrock resistivity is 410-770  $\Omega\text{m}$  while depth to the bedrock is 2.7-11.6 m. The geoelectric section beneath the Stable segment (Fig. 6) reveals three geoelectric layers defined as topsoil, clay and bedrock. The topsoil has resistivity ranging from 92  $\Omega\text{m}$  to 179  $\Omega\text{m}$  and is 0.8 m to 1.9 m thick. It is underlain by clay layer of resistivity 22-77  $\Omega\text{m}$  and thickness 2.9 m to 11.1 m. Bedrock resistivity and depth to bedrock range from 303  $\Omega\text{m}$  to 1104  $\Omega\text{m}$  and 2.9

m to 11.1 m respectively. The failure observed along the Failed segments cannot be attributed to bedrock fracturing as the values of reflectivity coefficients,  $R$ , at subsoil-bedrock interface, computed with saprolite resistivity,  $\rho_w$  and bedrock resistivity,  $\rho_b$ , range from 0.93 to 0.98, indicating fresh bedrock. A bedrock is suspected to be fractured when  $R$  is less than 0.7 [23].

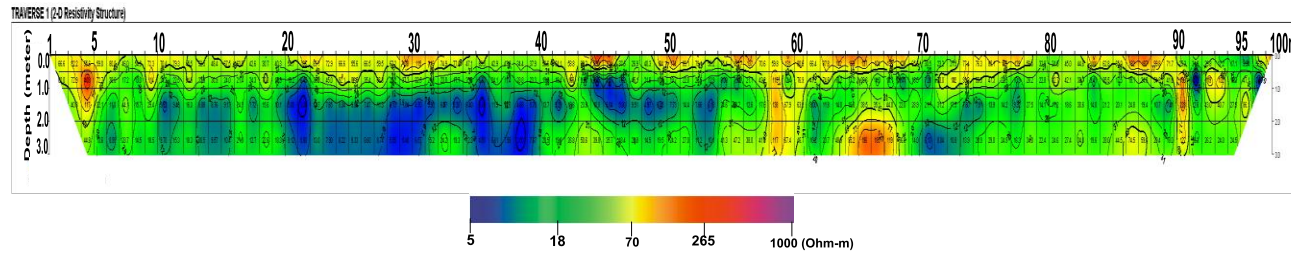
Fig. 7. 2D Resistivity section beneath Failed segment A

The 2-D resistivity section beneath Failed segment A (Fig. 7) reveals that the subgrade is characterized by low-resistivity soil material typically clay with resistivity,  $\rho$  ranging from 2.46  $\Omega$ m to 99.0  $\Omega$ m. Lenses of sandy clay ( $\rho = 101 \Omega$ m to 201  $\Omega$ m) and clayey sand ( $\rho = 254 \Omega$ m-320  $\Omega$ m) occur in places within the predominantly clay overburden. The resistivity generally decreases with increasing depth.

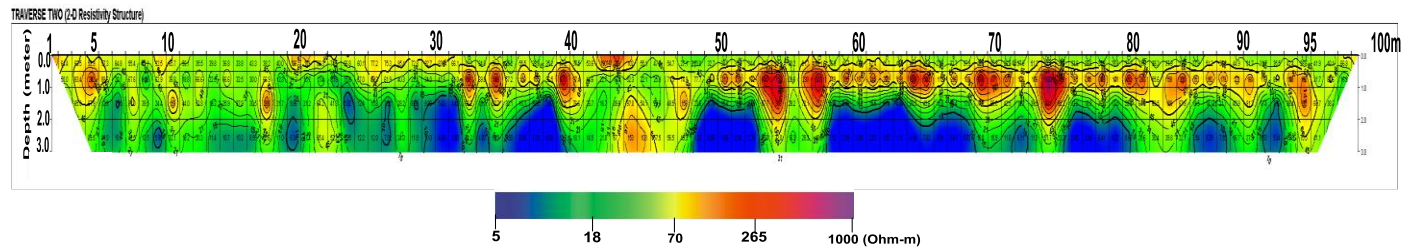
Fig. 8. 2D Resistivity section beneath Failed segment

The 2-D resistivity section beneath Failed segment B (Fig. 8) shows that the subgrade is predominantly clay with resistivity ranging from 0.83  $\Omega$ m to 97.4  $\Omega$ m. Sandy clay ( $\rho = 102 \Omega$ m-

245  $\Omega$ m), clayey sand 265  $\Omega$ m – 823  $\Omega$ m and sand ( $\rho = 1633 \Omega$ m) occur as lenses in places and at various depths within the subsoil. Since clay is porous but impermeable, it swells as rain water enters the subgrade through openings in the surface, and shrinks as it loses moisture in the dry season, causing differential settlement and eventual failure of the road pavement as it yields to vehicular load [12,15].

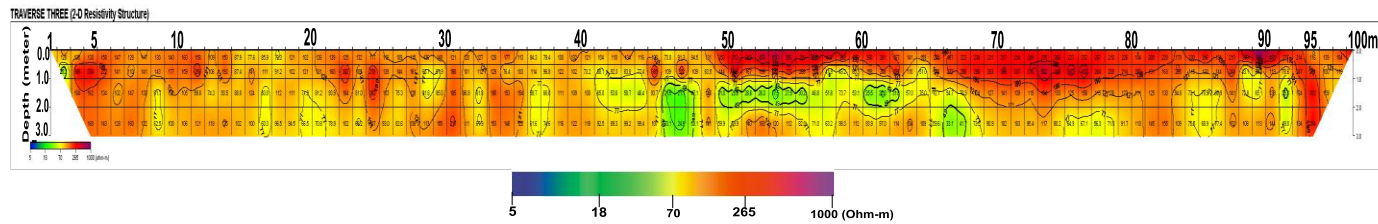
Fig. 9. 2D Resistivity section beneath the Stable segment

The 2-D resistivity section beneath the Stable segment (Fig. 9) reveals subgrade from station 1 to station 50 is predominantly sandy clay with resistivity ranging from 100 to 247  $\Omega$ m. The subgrade beneath stations 51 – 98 is characterized by relatively more resistive clayey sand, about 1 m thick, underlain by sandy clay. The resistivity of the clayey sand layer ranges from 258  $\Omega$ m to 530  $\Omega$ m. The predominance of the relatively higher resistivity materials beneath this portion is indicative of competence and stability of the subgrade against vehicular load [15,11].

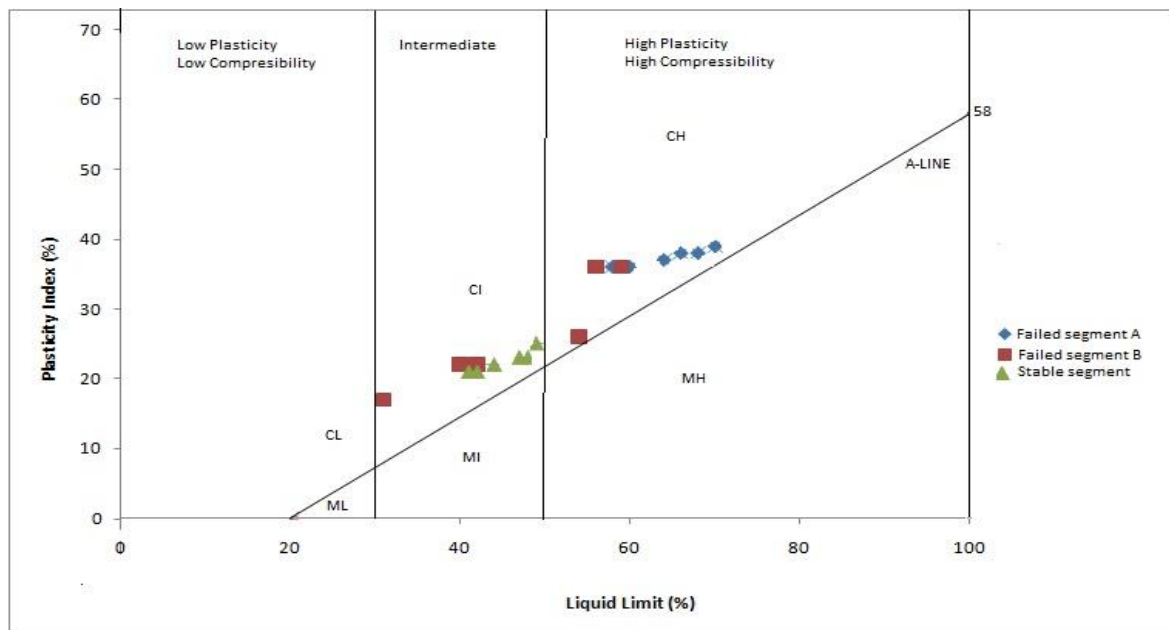
Fig. 10. Cassagrande chart of the soil samples

The subgrade beneath the Failed segments can be described as sandy clay within the top 0.5 m and sandy gravelly clay within the depth interval 0.5 m to 1.5 m. The fines are clay since the LL-PI values plot above the A-line on the Cassagrande (1948) chart (Fig. 10). The soils from Failed segment A have high plasticity and high compressibility while those from Failed segment B have medium-to-high plasticity and medium-to-

high compressibility. High Plasticity soils are known to display excessive shrinkage and settlement in response to seasonal variations [25,26] and this may have been the cause of the failure along these segments. The soils from the Stable segment are well-graded sandy clayey gravel of medium plasticity and medium compressibility.
